Advisory Region  
Bridger Range  
Longitude  
-110.96W

**Forecast link:** [GNFAC Avalanche Advisory for Wed Mar 9, 2011  
Bridger Range, 2011-03-08](#)

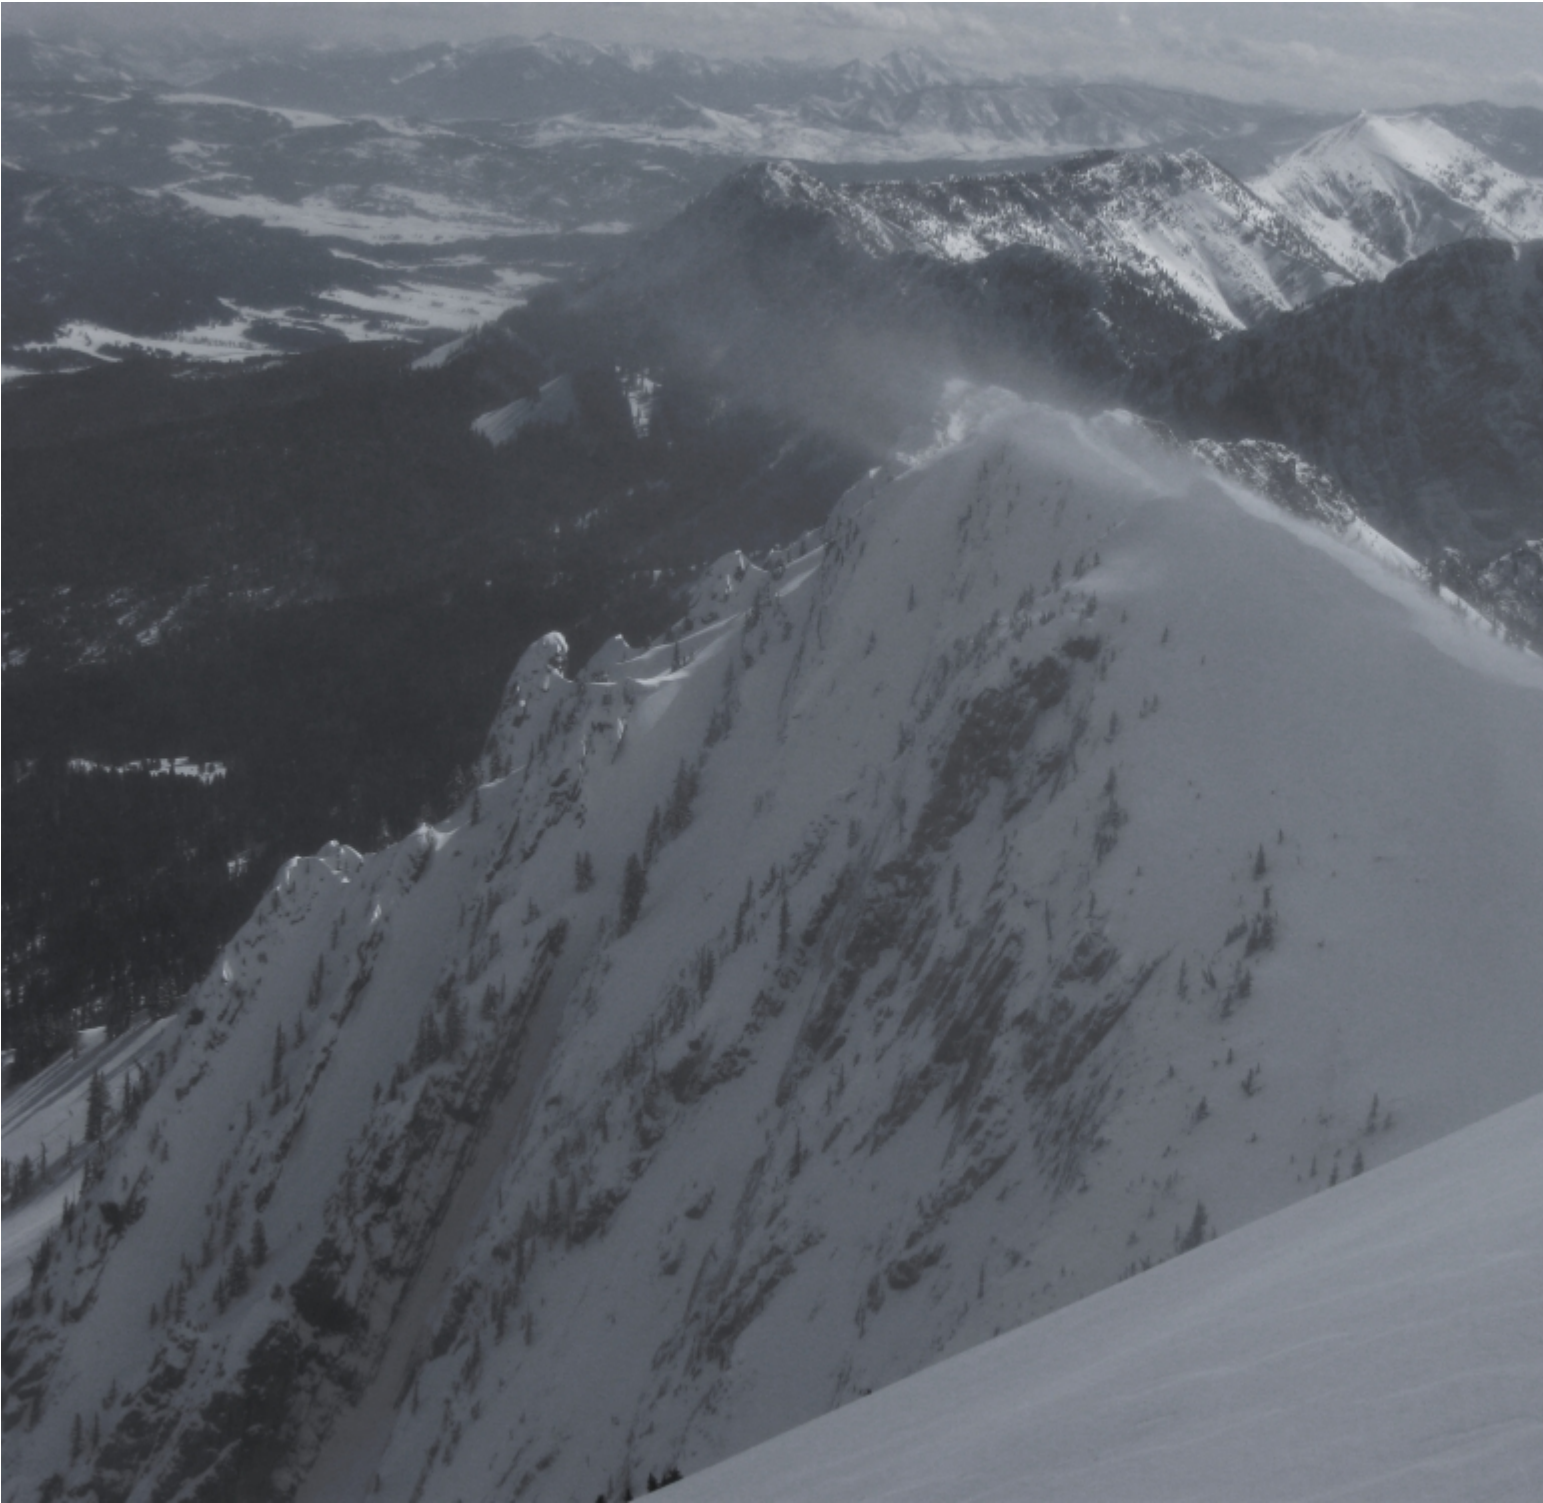
Plentiful snow on the west side of the Bridger Range was being transported to the East side. Fresh wind slabs were forming near ridgetops. As these wind slabs were forming they were starting to crack under my ski tips. With additional loading overnight these wind slabs should become much more sensitive. Photo: GNFAAC
